Crash Tests with Mercedes-Benz Viano to Assess the Secondary Safety

Multi Purpose Vehicles (MPVs) have gained great popularity for many years. To assess the secondary safety of the large MPV Mercedes-Benz Viano, Dekra conducted three crash tests according to the Euro NCAP test protocol: a 64-kph-40%-ODB frontal crash, a 50-kph-MDB side impact and a 29-kph-pole side impact. The paper describes the tests and the tested vehicle with its relevant safety features. The test results are shown with special attention to the dummy loads and their assessment including modifiers according to the Euro NCAP protocol.

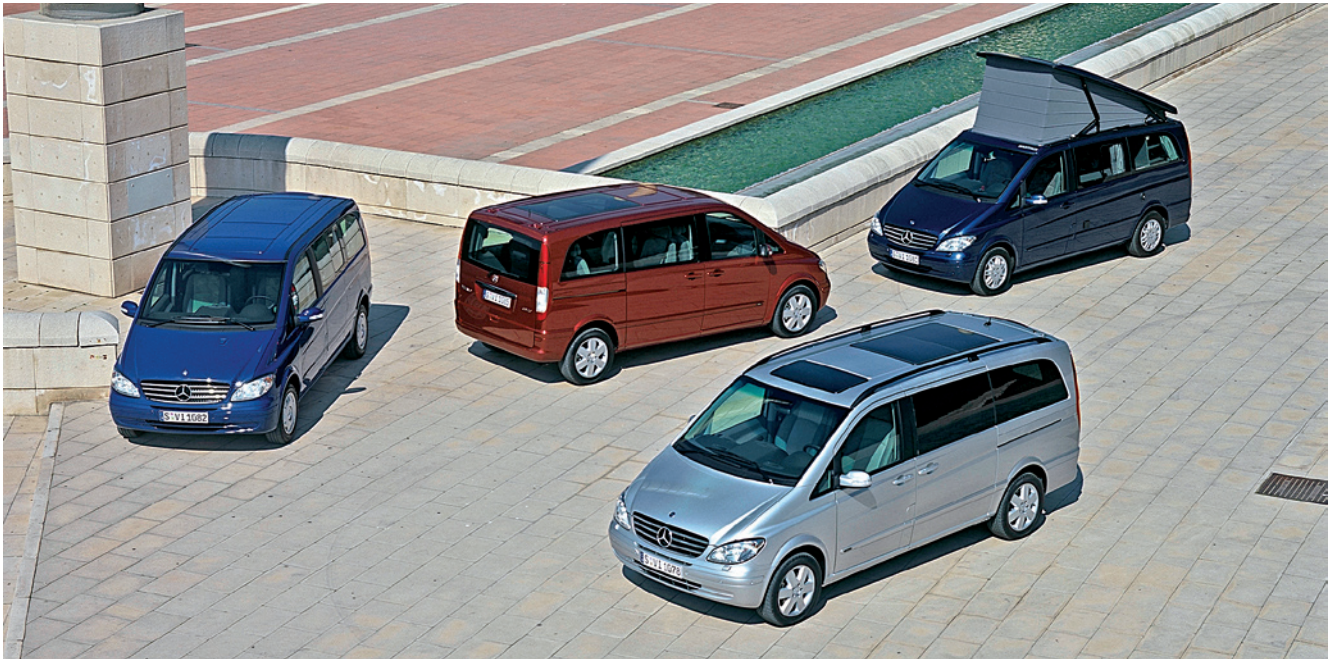
Figure 1: Variants of the Mercedes-Benz Viano

The crash tests were carried out on a new series Mercedes-Benz Viano, made in 2005, **Figure 1**. The manufacturer offers this six-seater vehicle in three versions. The compact variant has a length of 4,748 mm while the long- and extra-long variants have lengths of 4,993 mm and 5,223 mm respectively. The corresponding wheelbases are 3,200 mm for the compact- and long versions and 3,430 mm for the extra-long version. Depending upon the installed engine and equipment fitted, the kerb weight as determined in accordance with DIN 70020 lies within the range 2,020 - 2,195 kg while the gross vehicle mass lies between 2,770 and 2,940 kg.

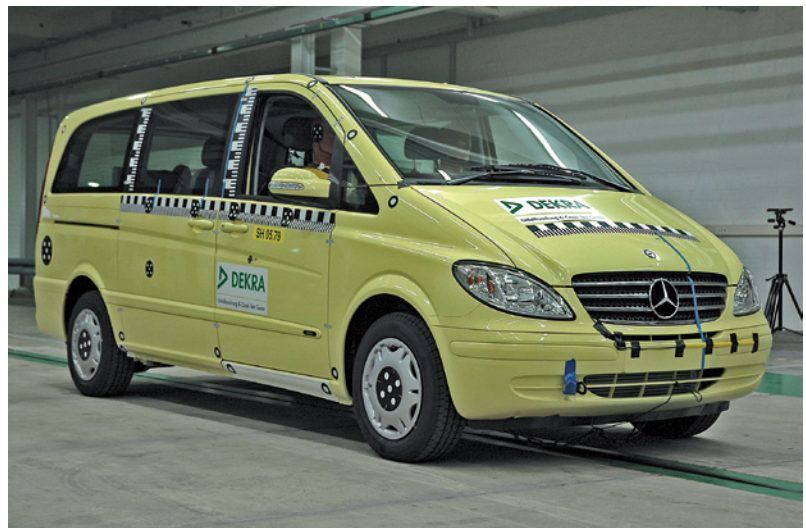
Figure 2: Test vehicle Mercedes-Benz Viano 2.0 CDI Trend

The particularly popular model 2.0 CDI Trend was chosen for the crash tests, **Figure 2** – the actual vehicle being the long version with a wheelbase of 3,200 mm, an empty weight of 2,065 kg and a gross vehicle mass of 2,770 kg. The total weight of the vehicle when prepared for testing amounted to 2,290 kg for the frontal impact, 2,158 kg for the side-impact with a moving barrier and 2,222 kg for the side-impact on a vertical pole.

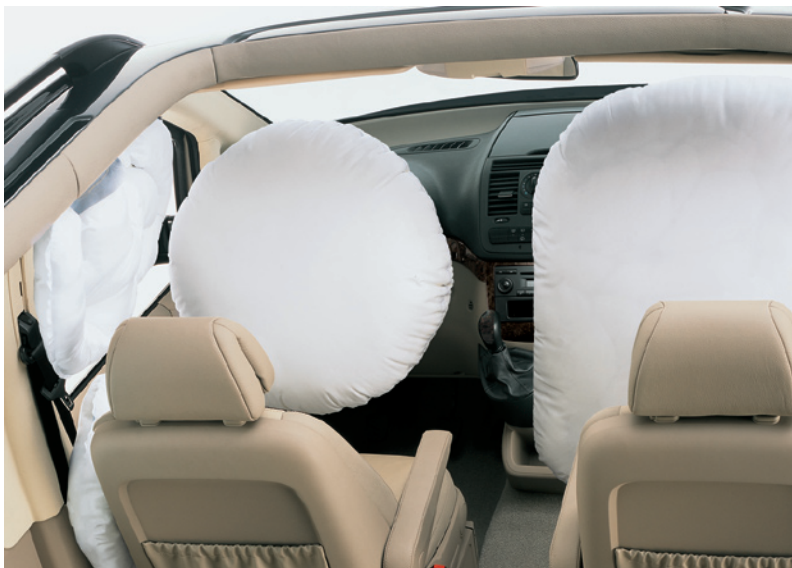
Figure 4: Airbags

All the seats are fitted with three-point safety belts. The systems for the driver and the front-seat passenger include a belt tensioner and a belt-force limiter. Front airbags for the driver and the front-seat passenger are provided also in series production models, **Figure 4**. Window airbags and thorax airbags can be provided for the driver and the front-seat passenger as optional fittings.

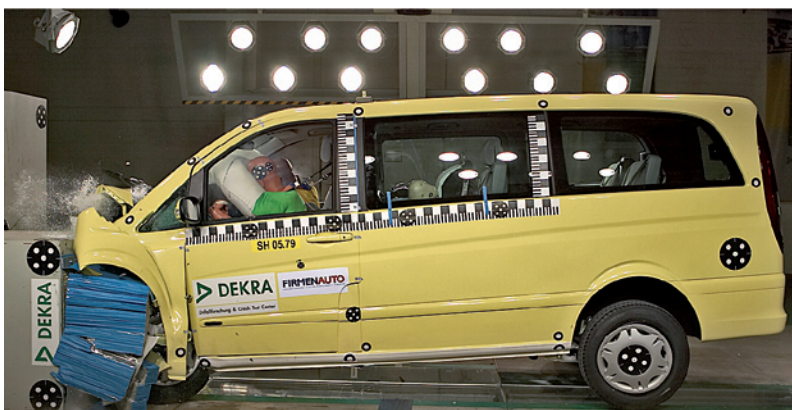
Figure 5: Frontal impact

In case of the frontal-impact test this takes place at 64.1 km/h with a frontal overlap of 40% with respect to the deformation element (ECE-R 94) on the fully rigid impact block, **Figure 5**.

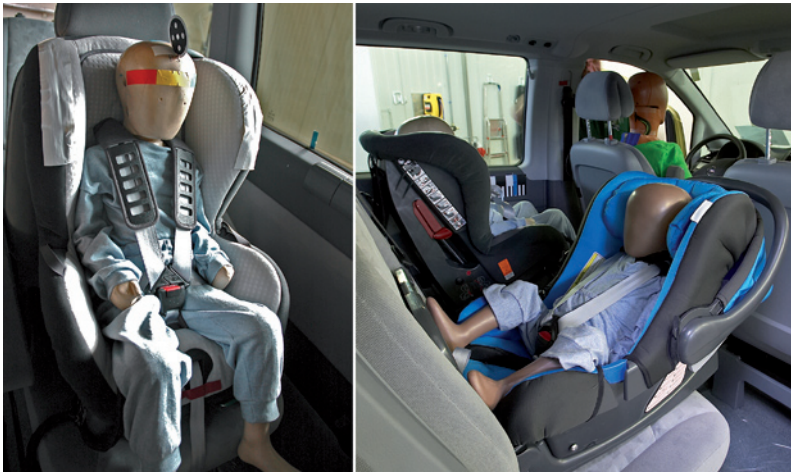
Figure 6: Child dummies P 3 and P 1½

centile male in both the driver seat and the front-passenger seat. Behind these in the second-row seats were two child dummies, **Figure 6**. A P3 Dummy (a three-year old child) was in the forward-facing seat (Römer Duo Plus) directly behind the driver. Behind the front-seat passenger was a P1-½ Dummy (a child 1-½ years old) in a rear-facing child seat (Römer Baby Safe Plus).

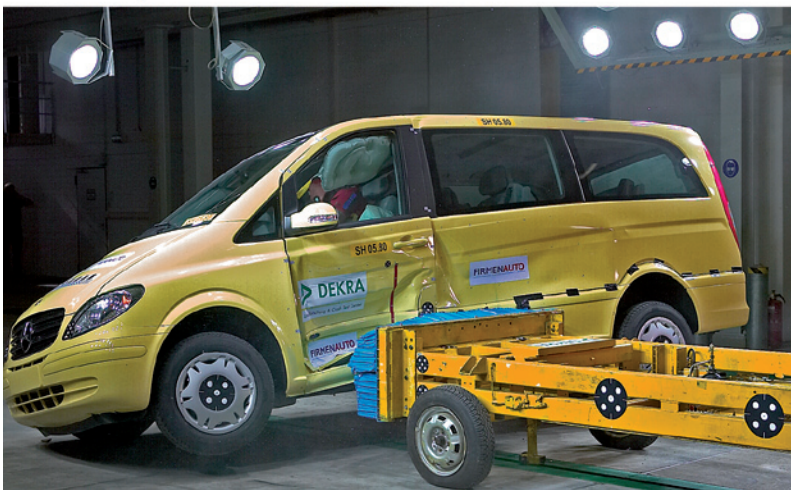
Figure 7: Side impact with moving barrier

During the first side-impact test the moveable barrier (with a mass of 944 kg and a deformable front element in accordance with ECE-R 95) impacted the side of the stationary test vehicle at a speed of 50.3 km/h. **Figure 7.** As required by the regulations, at the time of the impact the projection of the central vertical line of the barrier met the so-called „R-Point“ of the vehicle. The test vehicle was occupied by an adult dummy ES-2 on the driver side and two child-dummies in the second row of seats. As required by the testing procedure, on this occasion the P3 dummy was behind the front-seat passenger and the P1-½ dummy behind the driver.

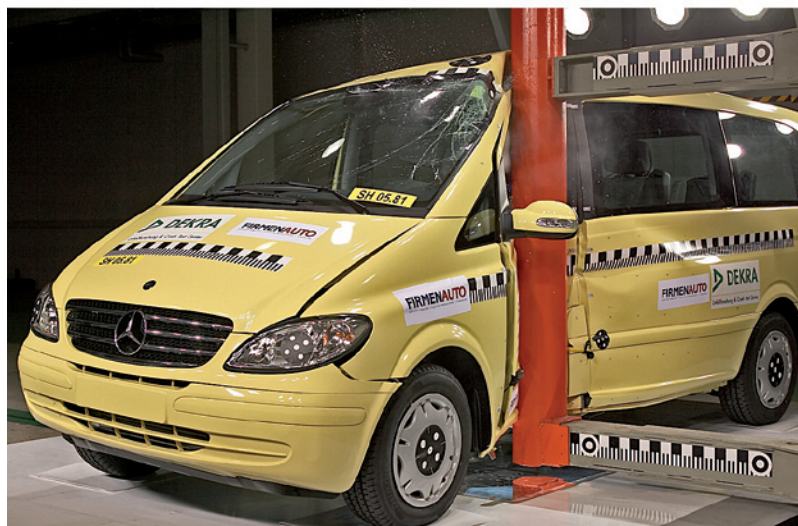
Figure 8: Impact with vertical pole

Since the Mercedes-Benz Viano can be fitted with side airbags for the head as an optional feature, an additional test conforming to the conditions imposed by Euro NCAP was carried out. This involved a side-impact collision of the test vehicle against a rigidly mounted pole (with a diameter of 254 mm), **Figure 8.** The impact speed was 29.1 km/h.

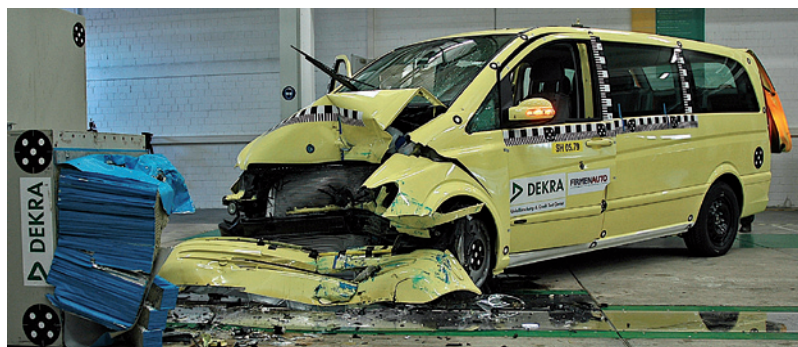
Figure 9: Test vehicle after frontal impact

Figure 9 shows the test vehicle after the frontal impact. Both front airbags and the belt tensioners for the driver and the front-seat passenger were activated in the manner expected in the event of such

a crash. As a result of the deformation caused by the crash the overall length of the left side of the vehicle was reduced by 643 mm while the right-hand side increased in length by 52 mm. In a corresponding manner, the wheelbase on the left-hand side was reduced by 305 mm while on the right-hand side it was increased by 175 mm.

The A-columns were displaced to only a very slight extent. The survival space for the occupants remained almost entirely intact. Table 1 contains the values for the displacement of the steering wheel, the brake-, clutch- and accelerator pedals in the horizontal (x), sideways (y) and vertical (z) directions. No rupture developed in the area of the underbody and splashboard. The bonnet crumpled and did not penetrate into the compartment. During the collision the doors remained closed. After the test the doors could be opened by hand without using tools.

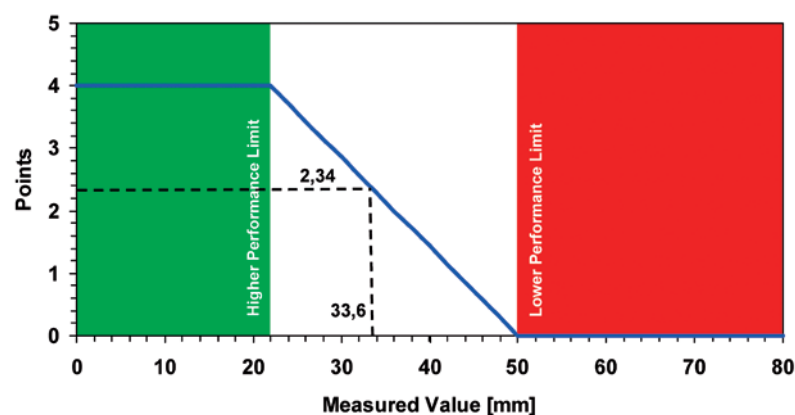
**Figure 10:** Assessment of the protection level relating to compression of the driver's chest

In the case of the chest compression of the driver dummy (33.6 mm) and the passenger dummy (32.73 mm), the higher performance limit of 22 mm was exceeded. In that situation the evaluation points for this body region have to be determined by reference to an appropriate

so-called sliding scale. For example, as shown in **Figure 10**, the driver dummy receives 2.34 points while his front-seat passenger receives 2.47.

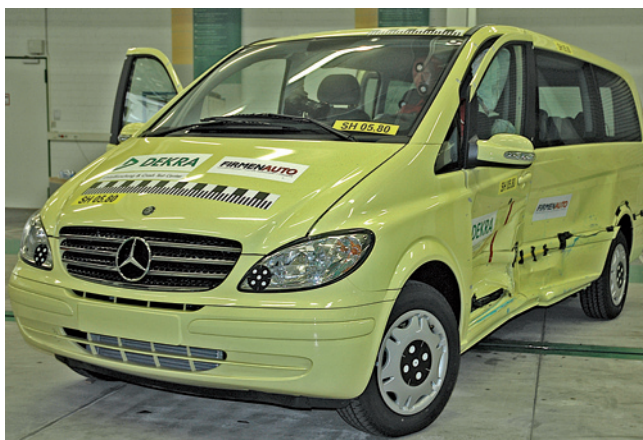
**Figure 14:** Test vehicle after side impact with moving barrier

The condition of the exterior body of the test vehicle following the side-impact collision is shown in **Figure 14**.

In the sill area the depth of deformation amounted to 110 mm with respect to the original contour of the vehicle. The most extensive depths of deformation were at a height of 150 mm above the sill level and amounted here to 250 mm.

After the collision, the driver door was jammed. The front-seat passenger door could be easily opened by hand without using any tools. As was to be expected, the collision caused the thorax side air bag and the head air bag to be activated. **Table 4** provides the measured loads experienced by the driver dummies (ES2).

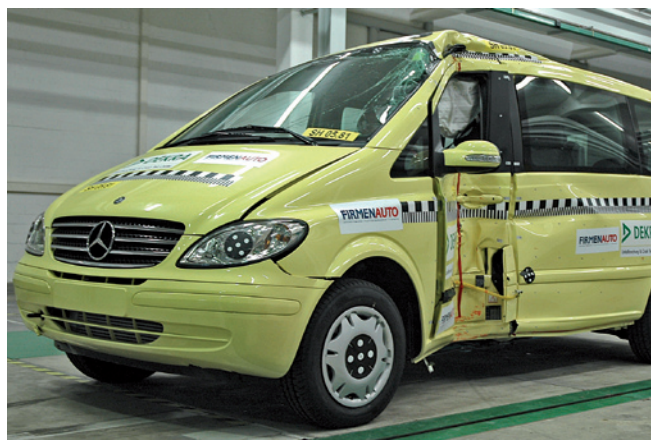
**Figure 15:** Test vehicle after pole impact

The external damage suffered by the test vehicle after collision with a vertical pole is shown in **Figure 15**.

With respect to the original outer contour of the vehicle body the maximal penetration depth by the pole was measured at 392 mm.
